Study on the microstructure and impact fracture behavior of martensitic alloy steels

Abstract

Martensitic steels used for ball mill liners were prepared. The effect of tempering on the microstructures, Rockwell hardness, and impact toughness of the tested steels was evaluated at room temperature. The fracture morphologies were observed by using metallurgical microscopy, scanning electron microscopy and energy-dispersive spectroscopy. The results showed that tempering decreased the Rockwell hardness and significantly improved the impact toughness of the tested steel. However, the impact toughness of the tempered steels was unstable. Fracture of the tested steel before tempering was quasi-cleavage fracture; however, it changed to ductile and quasi-cleavage fracture after tempering. Carbide segregations formed at the local grain boundaries became the crack source and were the preferred ways for crack propagation during the impact test. The existence of segregations was inferred to be the main reason for the fluctuation of impact toughness.

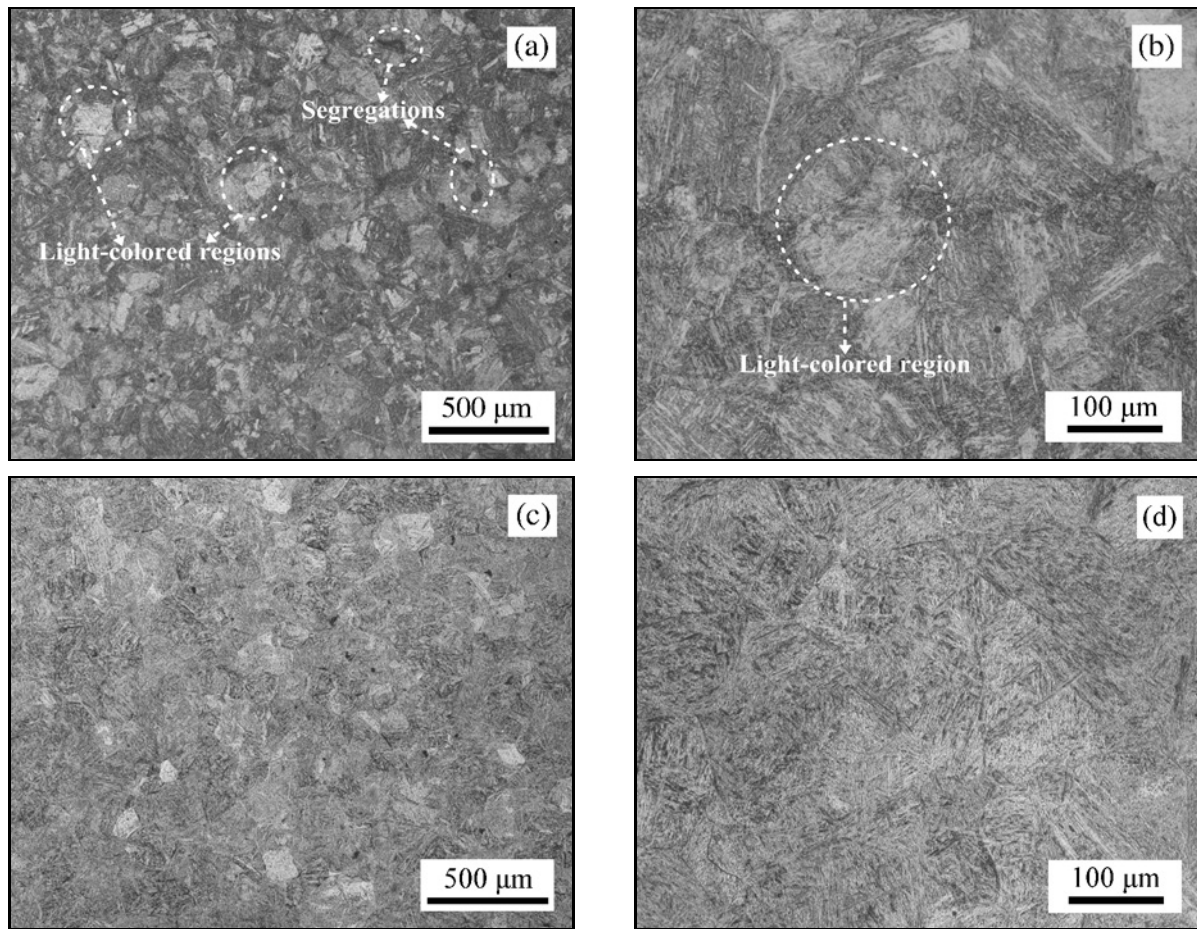
Fig. 1. Metallurgical structures of alloy steels before tempering (a), (b) and after tempering (c), (d).

Figure 1 shows the metallurgical structure of tested steel before (Fig. 1a,b) and after (Fig. 1c,d) tempering. The structure contains martensite mainly, which is consistent with the designing structure. It is apparent that light-colored and dark-colored regions appear in the microstructures of alloy steels. From the enlarged view in Fig. 1b, a certain amount of lath martensite has been observed in the light-colored region, which demonstrates that the light-colored region

also consists of martensite. It is inferred that the different regions are lath martensite developed during martensitic transformation because of the differences in transformation sequences and temperature [16, 17]. The martensite in the dark regions was supposed to be formed at a later stage of martensite transformation, which maintained a high dislocation density. The martensite in the light-color regions was supposed to be formed at the beginning of the martensite formation with a relatively high temperature and exhibited reasonably low dislocation density because of greater recovery of dislocations throughout the extended period of transformation [18]. At the same time, residual austenite gradually transformed into martensite that is dark. In addition, segregations had been discovered in the steel before tempering [19, 20]. The stability of the material properties may be affected by these segregations.

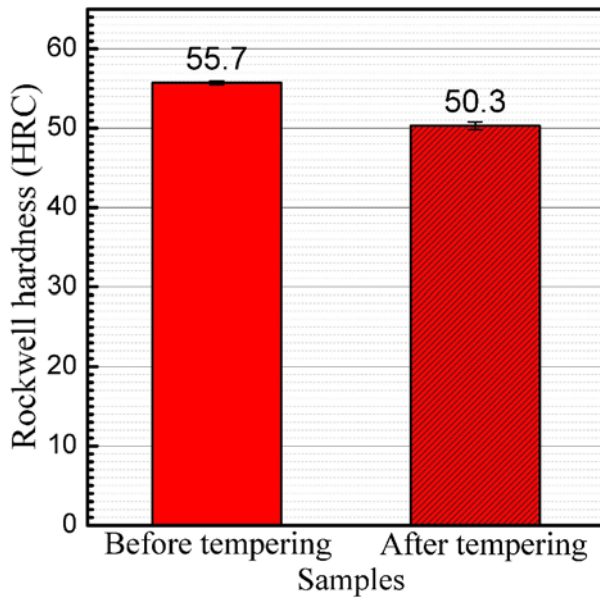
Fig. 2. Rockwell hardness of alloy steels.

Figure 2 shows the Rockwell hardness of the tested steel. The Rockwell hardness of the tested steel before and after tempering was 55.7 and 50.3 HRC, respectively. Tempering decreases the hardness of steel. This is mainly because of the decomposition of martensite during tempering and the ejection of carbon atoms from the carbon supersaturated martensite phase [24]. The key element carbon that greatly contributes to the high hardness in martensite has been consumed to form carbides.

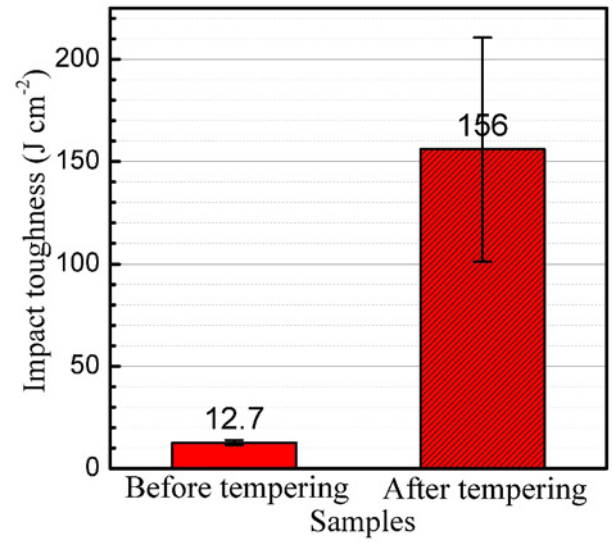
Fig. 3. Impact toughness of alloy steels at room temperature.

Figure 3 shows the impact toughness of the tested steel before and after tempering. The result shows a

large difference between the alloy steels before and after tempering. The impact toughness of the untempered specimen was 12.7 J cm^{-2} , whereas the result after tempering was significantly improved to 156 J cm^{-2} . Tempering of martensitic steels is essential to suppress brittle fracture and ensure the desired combination of strength and ductility. Therefore, tempered martensite has received increasing attention and is becoming one of the phases present in most of the advanced high strength steels [25]. However, the process of tempering is complex for different martensite steels. In the current work, the main reasons for the different properties are inferred as follows. First, the cooling rate for the quenching of steel in oil was relatively fast, resulting in high residual stress in the specimen. During the impact test, the residual tensile stress promoted the initiation and propagation of cracks, and the specimen was easily fractured. However, it is well known that tempering is effective in eliminating residual stress [26]. Therefore, the resistance of the tempered specimen to fracture improved. Second, the transition carbides precipitated during the tempering process were coherent with the matrix, therefore hindering the motion of dislocations and, thus, raising the strength of the steel [27]. Additionally, segregation may be an important reason for the low impact toughness of specimens before tempering. As shown in Fig. 1, segregations around the grain boundary were sensitive to fracture. It is very interesting, but confusing, that the specimens after tempering exhibited fluctuant results for impact toughness.

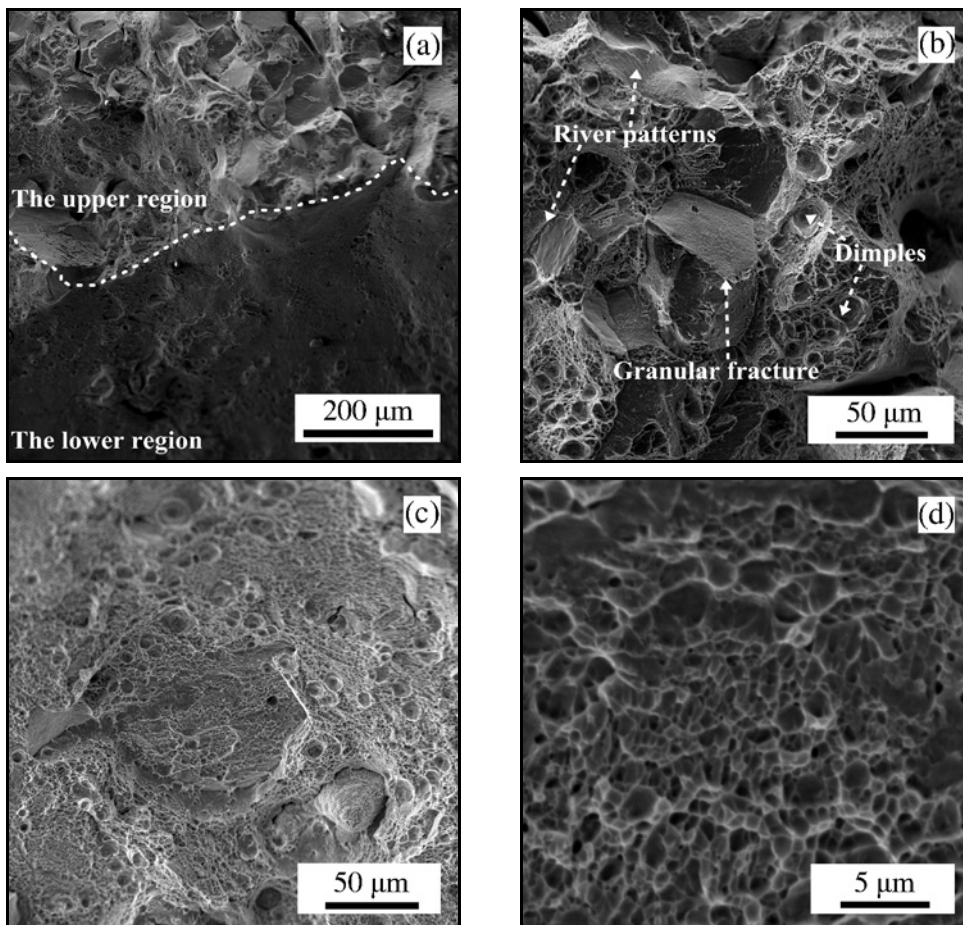
Fig. 4. Fracture morphologies of the tempered steel.

The fracture morphologies of the tempered parallel specimen are shown in Fig. 4. The fracture morphologies are complex. Two different regions are shown in Fig. 4a. The upper region (Fig. 4b) of the figure shows the quasi-cleavage fracture. It is a fracture mode between cleavage fracture and dimple fracture [28–30]. River patterns, granular fractures, and dimples are the main features of this region. Cracks initiate at different positions of the structure and then propagate discontinuously. The granular fracture region shows a smooth interface (Fig. 4b), which is different from the rough dimple fracture. Generally, this type of fracture occurs because of the precipitation of continuously or discontinuously distributed brittle phases along the grain boundary. Under the action of external tensile forces, the weak precipitates are easily damaged, and cracks start to propagate along the grain boundary, resulting in the fracture of the specimen. The lower region shows an obvious ductile fracture characteristic, which is more evident from the enlarged Fig. 4c,d [31]. A large

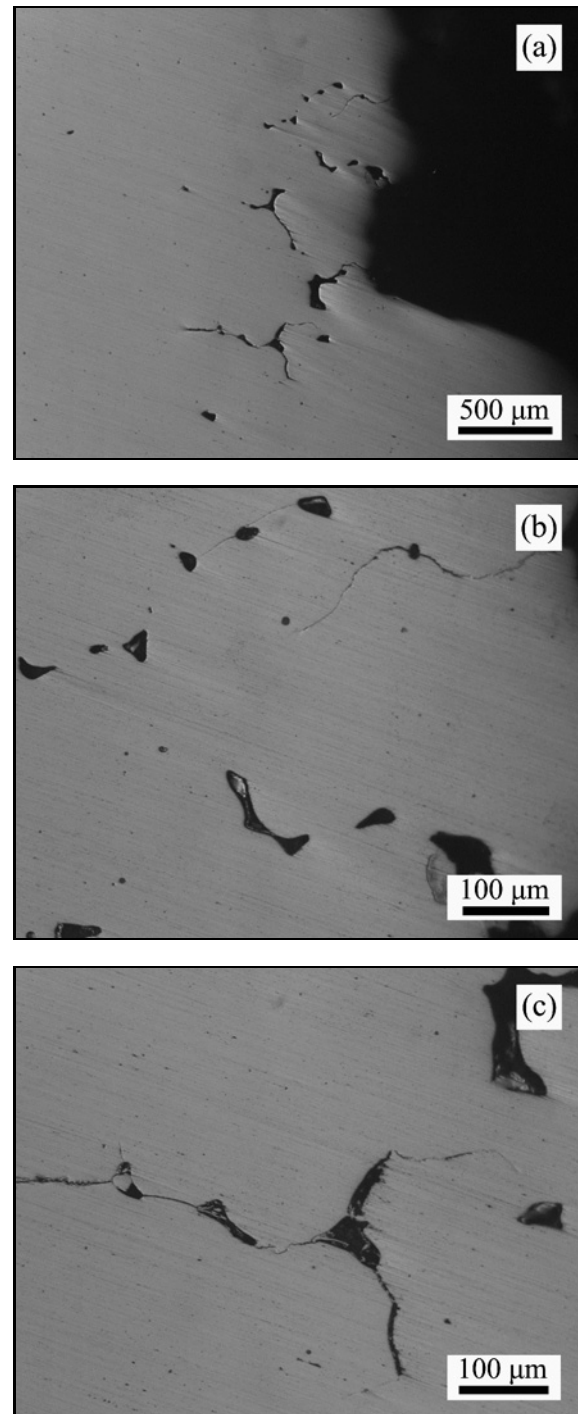
Fig. 5. The side view of the fractured specimen.

Figure 5 is the metallurgical structure showing the side of the fractured surface. Many holes were discovered at the edge of the fracture. The shapes of the holes were not the same. Some of them appeared island-like, whereas others were irregular strips. The causes for the formation of the holes are as follows. First, they were the casting defects, such as looseness and gas holes, which formed before the impact test of the specimen. Second, they may have resulted from the smashing of some weak phases or structures when subjected to strong tensile stress during the impact test. It is certain that these holes greatly affected the impact resistance of the alloy steel. They provided the position and condition for the initiation of cracks. Also, cracks tended to propagate along the connection path of adjacent holes.

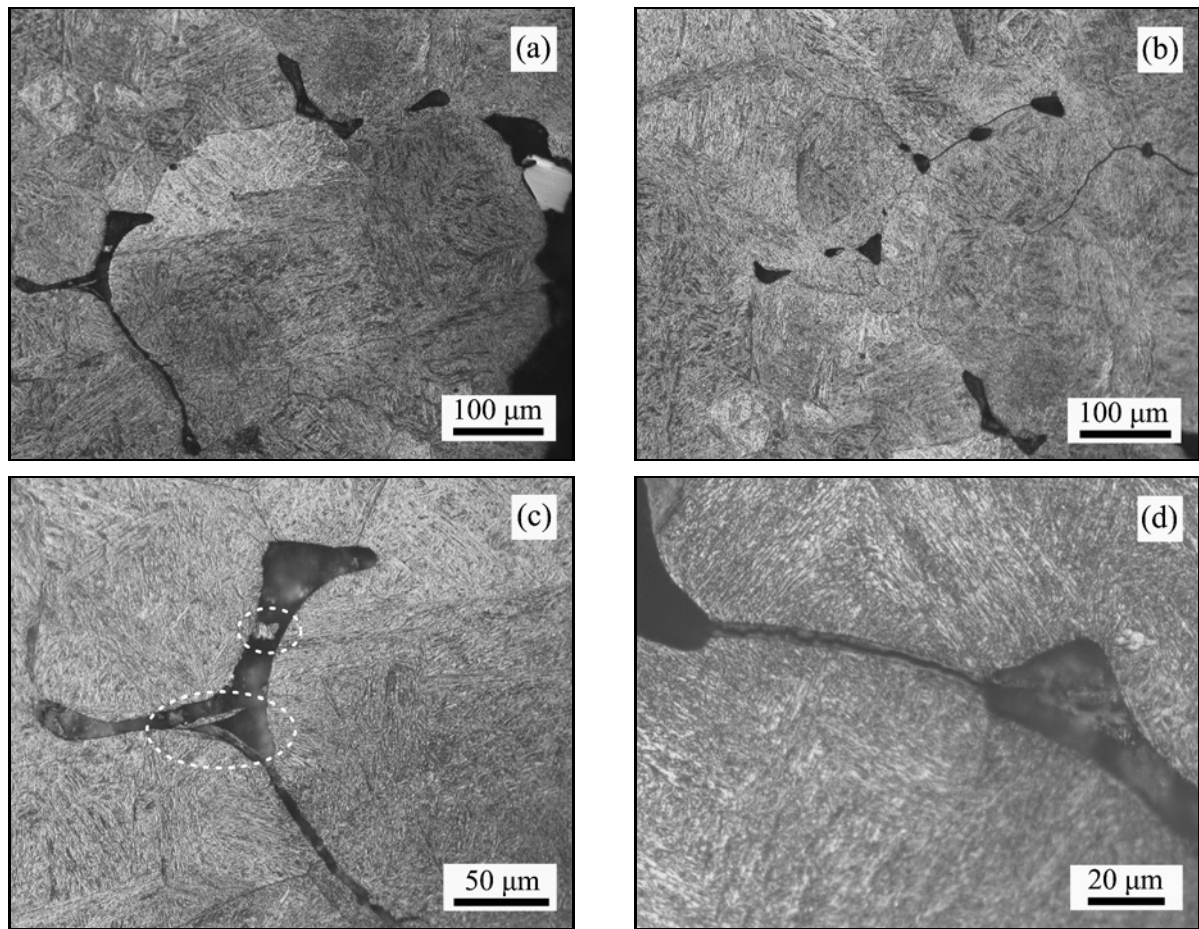
Fig. 6. Metallurgical structures showing the side of the impact fracture of the etched specimen.

The etched side view of the fractured specimen is shown in Fig. 6 to show further the reason for the formation of holes. The microstructure of the specimen after impact was still martensite. Most of the holes distributed along grain boundaries, and there were no obvious holes inside the grain. The distribution feature

of holes can provide preferred ways for crack propagation during the impact process. Cracks expanded easily between two holes, as seen in Fig. 6d, finally leading to a bigger one. A significant discovery shown in Fig. 6c is that there were residual materials in the holes, as circled in the figure. This discovery indicates that the holes in the specimen were not casting defects, such as looseness or gas holes formed during the casting process. This result was most probably caused during the deformation, crushing, and detachment of some special structures during the impact process.

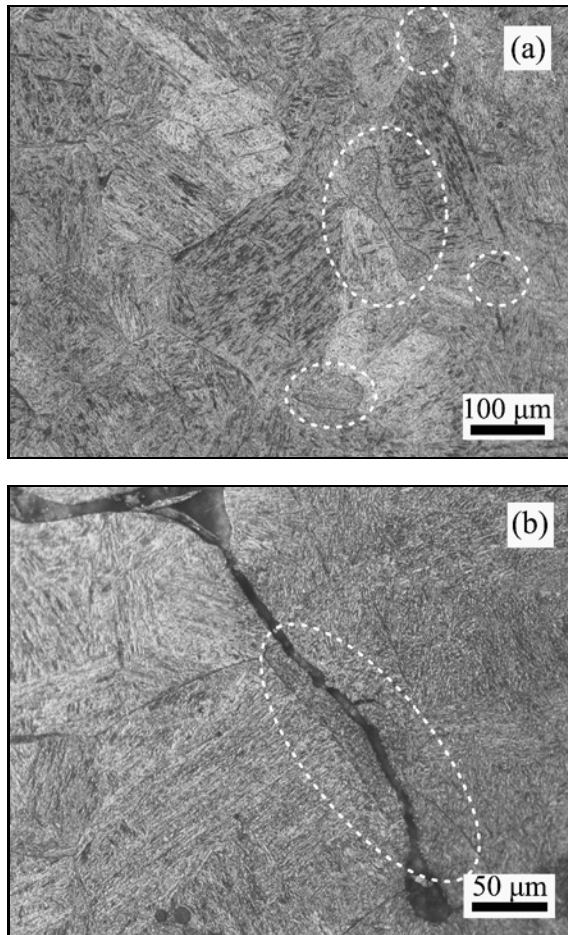
Fig. 7. Metallurgical structures showing the special zones.

It is interesting to investigate whether the structures of the holes and the matrix were the same. This investigation was carried out on the structures of the specimen, as shown in Fig. 7.

Several segregation zones were found in the tested steel. A large number of fine particles were inside the segregation regions. Interestingly, the shape of the segregation zone appears as “island-like” and “bone-like” shapes that exactly match the shapes of the holes observed above. These special zones occurred along the grain boundary, which is consistent with the distribution of holes. This coincidence implies that the formation of holes was caused by the destruction of the segregation zones in the alloy steel during impact.

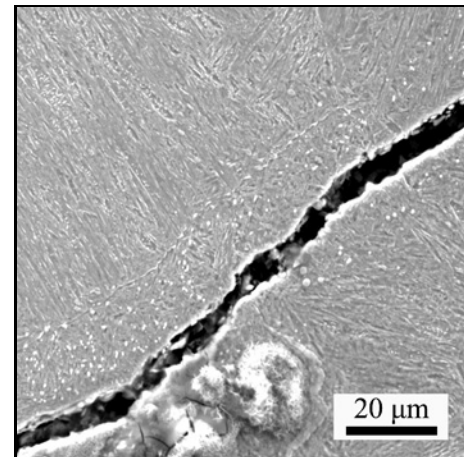
Fig. 8. Scanning electron microstructure of the segregation zone.

The localized structure segregation was the main reason for the formation of holes and the development of a large number of cracks in the specimen. SEM was used to observe the segregation zone shown in Fig. 7b and the result is shown in Fig. 8. Many white dots were detected in the bonelike segregation zone. The further analysis from EDS (as shown in Table 2) indicates that the white dots are mainly Fe-Cr carbides. Carbides usually serve as crack sources [19]. Carbides such as $M_{23}C_6$ and M_7C_3 are incoherent boundaries with the matrix structure. Because of the incoherent boundaries, there was a small gap between the matrix and the precipitate. When a small force was applied to these gaps, the gap grew into microvoids by stress concentration. The pass-through of the crack proved that

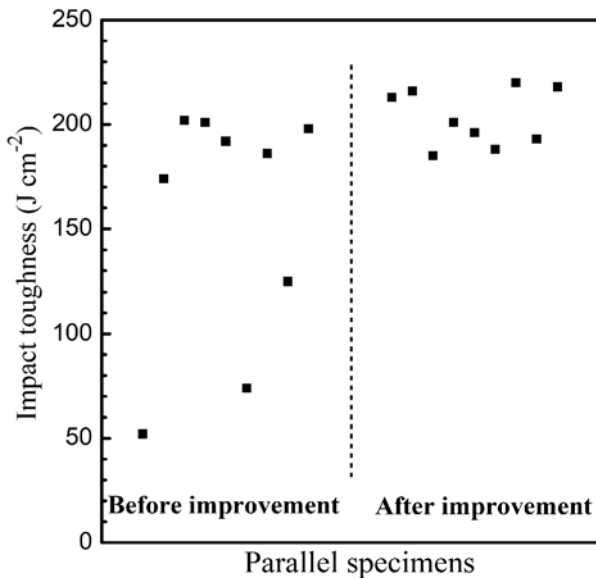
Fig. 9. Impact toughness results of the alloy steels before and after improvement.

To eliminate the segregation along grain boundaries, the temperature of annealing was increased to 1100°C . After the same processes of quenching and tempering, many parallel specimens were prepared to conduct the impact test. The result of the impact toughness before and after the improvement is shown in Fig. 9. The result for the parallel specimens after the improved treatment was steadier than that of those treated at temperatures ranging from 1020 to 1050°C . All specimens held superior impact toughness at room temperature. This indicates that increasing the annealing temperature is an effective method for

eliminating the Fe-Cr carbides along the grain boundaries, resulting in the stability of impact toughness.
